Las Ventanas Erosion Repair

SL11970-1

Las Ventanas Tract
Arroyo Grande Area,
San Luis Obispo

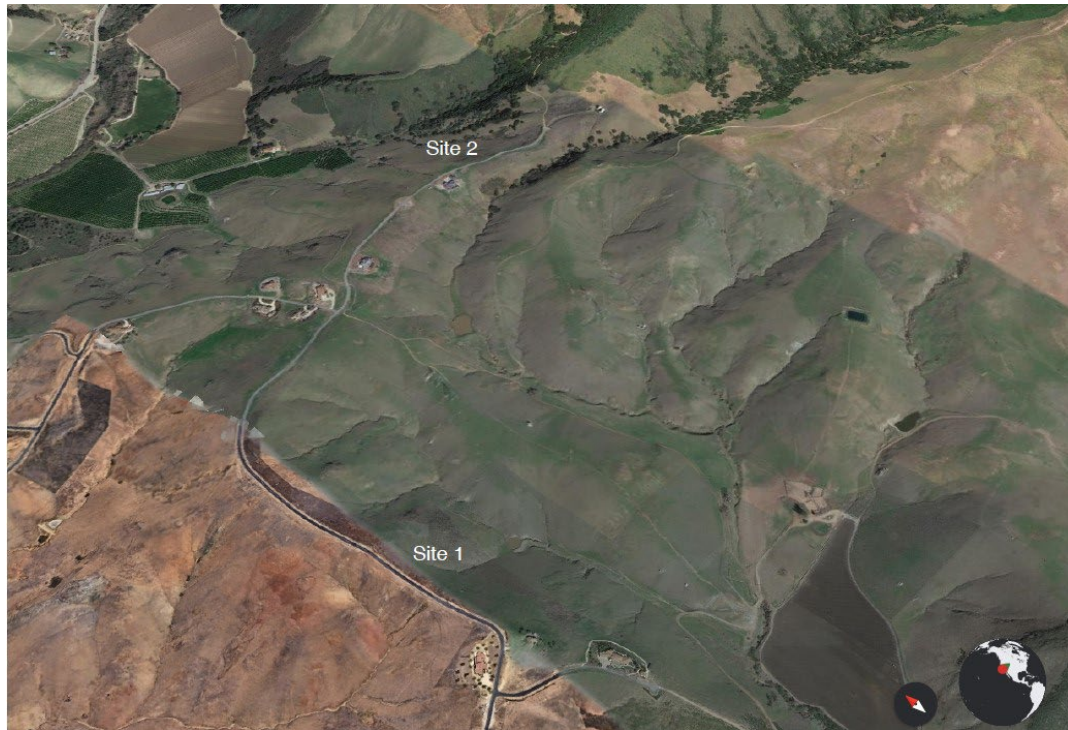
Figure 1: Erosion Locations

GeoSolutions, Inc. was contacted to help develop repair recommendations within the Las Ventanas Tract. During this year's rainy season two areas have significant erosion. The erosion is in existing drainage paths. Site 1 is located adjacent to Camino San Gabriel and Site 2 is located off Camino Purisima. The purpose of this revision is to include the locations of the erosion sites. See Figure 1 below for approximate locations.

An existing drainage pipe coming off Camino San Gabriel, Site 1, has created a down cut to rock. The down cut is migrating uphill and could threaten the roadway and existing utilities.

Site 2 has eroded a deep incised channel exposing rock. It appears the headwall of the erosion is relatively stable. At Site 2 we recommend the placement of large rock, approximately 1-to-2-ton stone placed on a non-permeable fabric. The large stone should be filled with smaller 6-to-12-inch rock to fill voids and lock the system together.

This area can be graded in a way to restore prior contours. To grade this area the soils will need to be "keyed and benched" into underlying rock, see attached key and bench detail.

The surface drainage from the roadway should be conveyed by pipe to the bottom of the hill. At the point of discharge a concrete or rock structure is required to slow velocities and limit future erosion.
