Las Ventanas Erosion Repair

SL11970-1

Las Ventanas Tract
Arroyo Grande Area,
San Luis Obispo

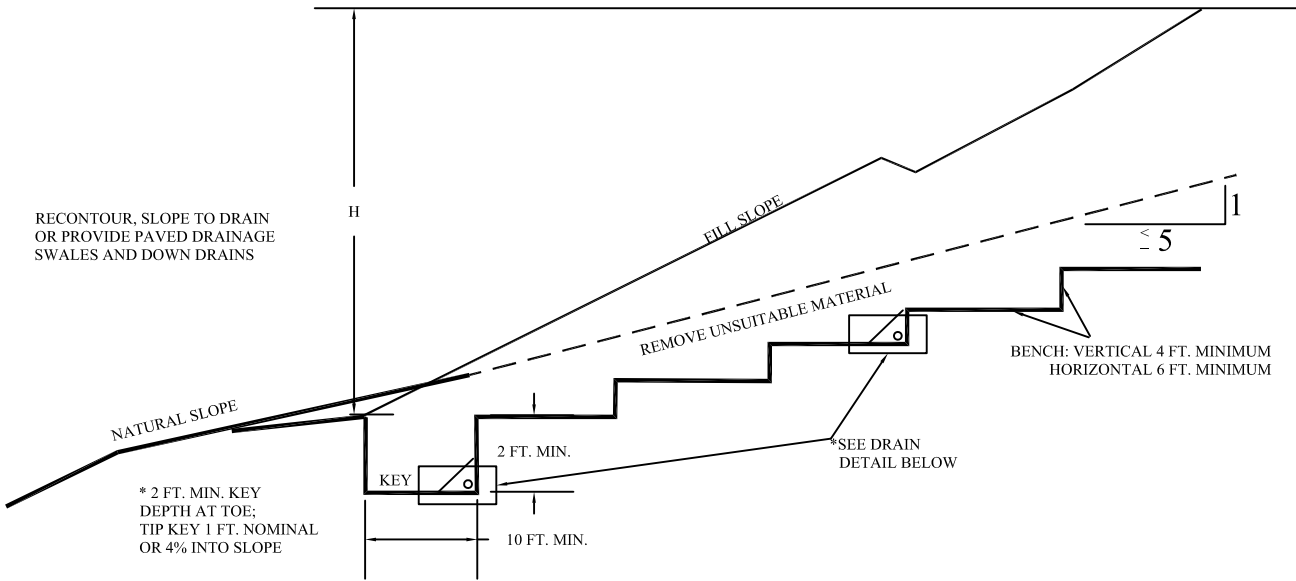
FILL OVER SLOPE

An existing drainage pipe coming off Camino San Gabriel, Site 1, has created a down cut to rock. The down cut is migrating uphill and could threaten the roadway and existing utilities.

This area can be graded in a way to restore prior contours. To grade this area the soils will need to be "keyed and benched" into underlying rock, see attached key and bench detail.

RECONTOUR, SLOPE TO DRAIN
OR PROVIDE PAVED DRAINAGE
SWALES AND DOWN DRAINS

REMOVE UNSUITABLE MATERIAL

BENCH: VERTICAL 4 FT. MINIMUM
HORIZONTAL 6 FT. MINIMUM

* 2 FT. MIN. KEY
DEPTH AT TOE;
TIP KEY 1 FT. NOMINAL
OR 4% INTO SLOPE
